Number: 2009/02

LEAKS IN CARGO TANK LINES ON BOARD A CHEMICAL CARRIER

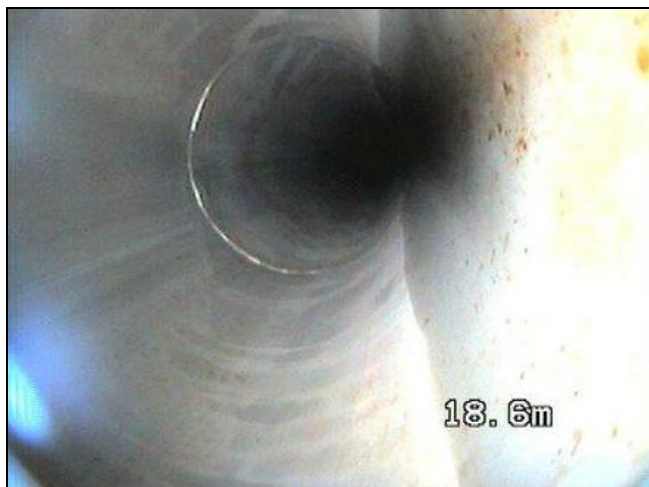
Line 1 – Extensive rust spots, most likely caused by free iron/oxides trapped on surfaces

The report's recommendation was to perform a chemical cleaning of the deck cargo lines and cargo stripping lines. The effect of this chemical cleaning (pickling) is to remove the oxides at the heat affected zones along the piping length where welding was done, thereby allowing the steel surface to come into contact with oxygen from the air, and form the

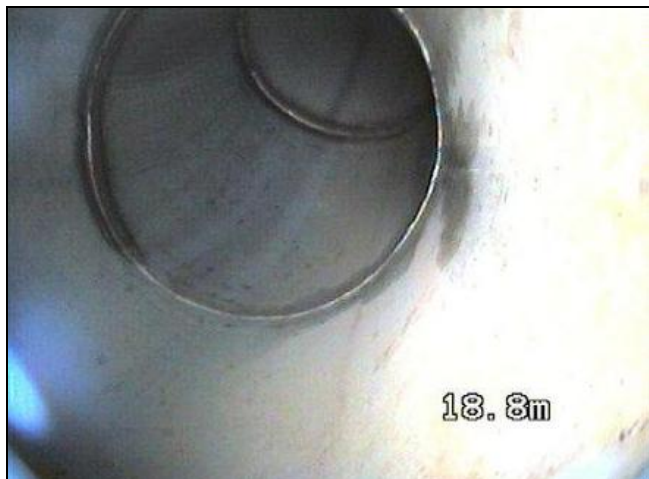
Line 2 – Evidence that at one time the piping had been half submerged in a pickling acid, with the lower half circle of weld seam pickled and the upper half circle untreated

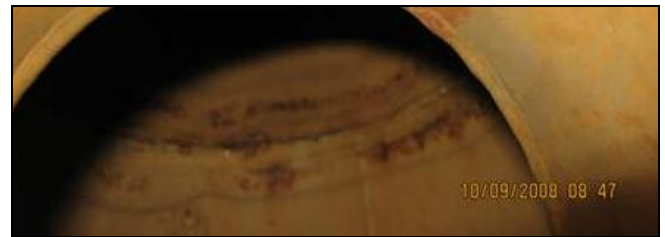
Line 3 at portable pump connection – weld seam contaminated and showing signs of extensive corrosion products

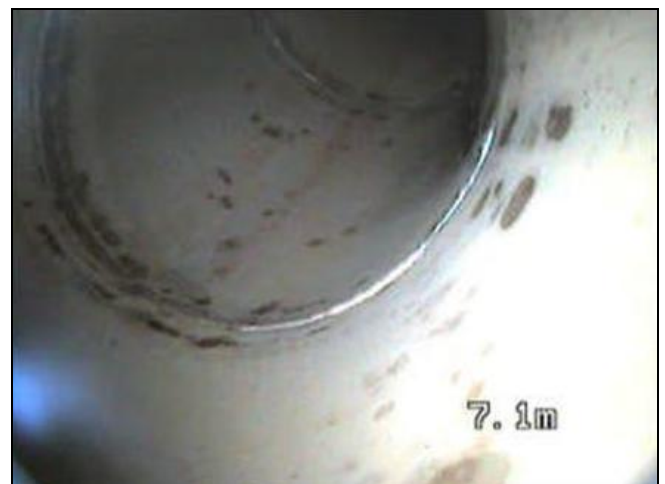
Line 4 – Extensive contamination, especially near weld seams, possibly caused by free iron/oxides trapped on surfaces

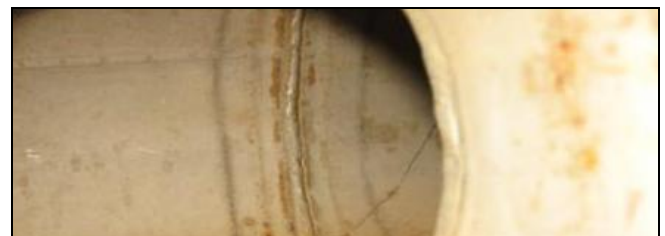
Line 5SB at portable pump connection (before treatment) – weld seam contaminated and showing signs of extensive corrosion products

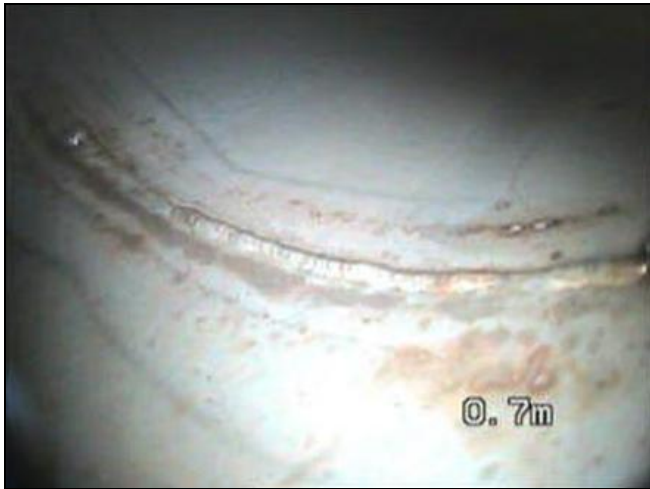
Line 5SB (before treatment) – Weld seams contaminated with significant corrosion products

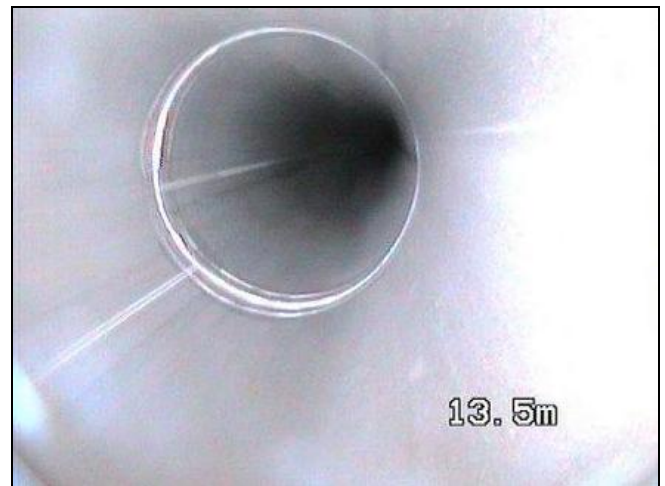
Line 1 (after treatment) – Cleaning and pickling successful

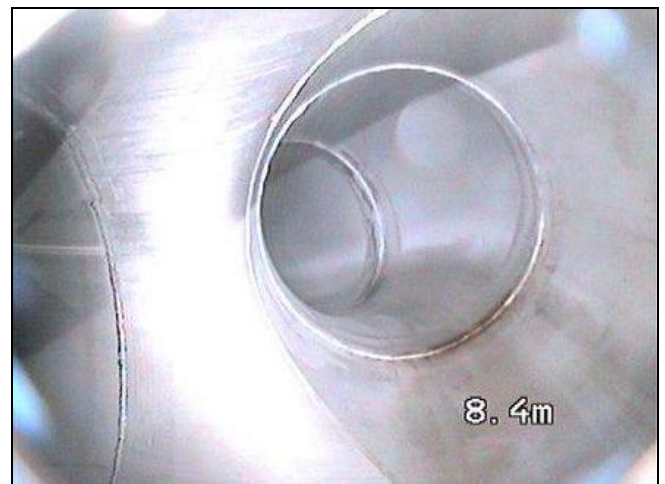
Line 4 (after treatment) – Pickling successful, some evidence of trapped air pockets caused by vessel trim

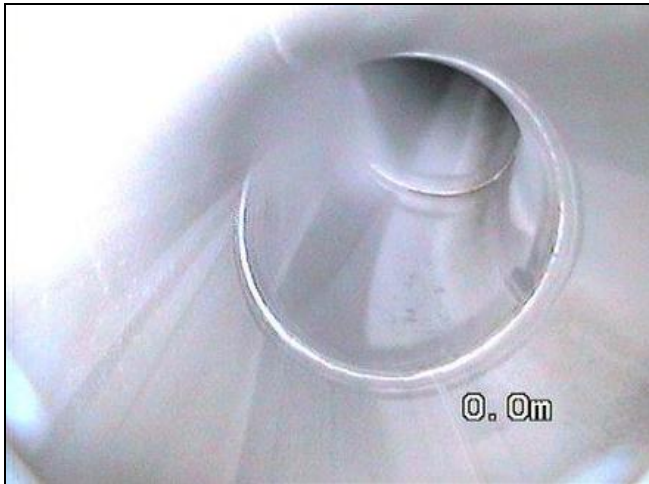
Photos and boroscope inspection of line 5SB – successful pickling
