Number: 2007/08

## STAINLESS STEEL IN ARCHITECTURAL CONSTRUCTIONS, BEAUTIFUL BUT DELICATE

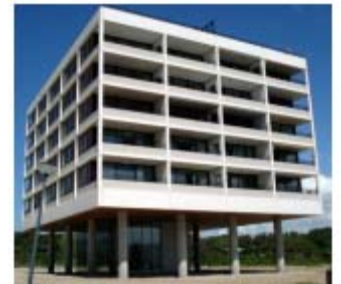
This apartment complex consist of 3 equal blocks and was finished in the course of 2006 and the beginning of 2007. It is situated on a few hundred meters away from the sea. Air measurements have shown that sea air contains high concentrations of chlorides which are transported by wind up to 35 miles land inwards. This concentration is in general already high enough to penetrate through the chromium oxide layer of stainless quality 304. In other words, stainless quality 304 applied in coastal areas will start to "rust" within weeks if it is not maintained properly. Also 316 quality will eventually start to rust in these areas, but it will take substantially longer than with the 304 quality.

The apartments at the Beach Road had stainless steel letterboxes on the outside of the entry. Within 6 months however, they started to show corrosion. The active committee of house owners asked their facility maintenance company, Van Holstein, to solve the problem.

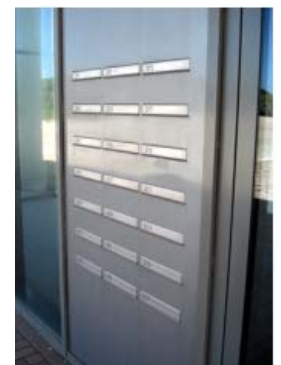
Dennis van Holstein, owner of this company explained us: "We really did not know what to do about it at first. Regular cleaning products don't remove rust. Also we did not have a clue whether the products we tried made the situation any better or worse. I know there are products on the market to remove rust, but in general these are highly acid products that I wouldn't like my people to work with!" Therefore Van Holstein searched for a user friendly solution to solve the corrosion problem at the apartments on Beach Road, that now also spread to some poles meant to support parked bicycles. There search lead to one of the other customers of Van Holstein: Vecom.

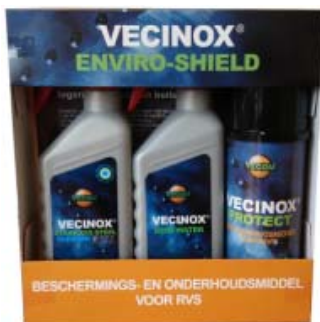
Dennis van Holstein continues his story: "At Vecom they understood immediately what was going on and also understood that I was not planning to use heavy chemicals as part of my daily routine cleaning buildings. Besides that, an online search showed me that such chemicals were sold per 10 or 25 liter drum, much more than I need for a few letterboxes and poles." Fortunately we just developed a kit for

maintenance of stainless steel called "Enviro-Shield". This kit not only provides the 3 products to maintain and protect stainless steel, it also clearly explains the principle of stainless steel. The user is educated in a clear and understandable way why he should always follow certain steps to keep his stainless steel in tact, even when slight corrosion is already showing

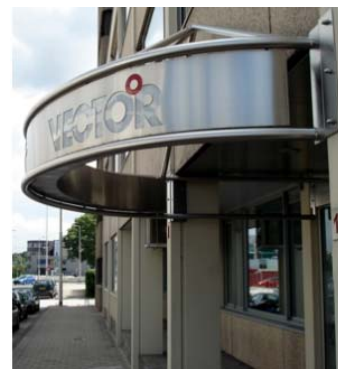
At Vector in Rotterdam, Van Holstein also experienced a maintenance problem with a stainless steel construction. The duct hanging over the entry of the Vector building showed corrosion. The type of stainless steel that was used for the construction is of good quality (316 or higher grade) and was fitted in 2005. After one-and-a-half year it started to show a modest corrosion on the surface. Roland Borst of

the Vector Facility Management explains: "We tried to solve the problem ourselves with these silver/blue spray cans "stainless steel polish". They made the uncontaminated parts shine really well but it didn't stop the corrosion." At Vecom we are familiar with those kind of products. The Vecinox Protect spray that comes in the Enviro-Shield kit is a similar product. In general these products are harmless as long as you realize what you are doing. An uncontaminated surface will indeed shine and even be "protected" with such a product, but when you apply it to a surface that already is showing corrosion you can make the problem worse. You can lock elements like chlorides and foreign steel particles under a layer of the product (Protect spray or similar products), shutting the stainless steel surface from oxygen. This means the chromium oxide layer has no chance repairing itself. The chlorides or other contamination will "eat" their way through the surface, creating "pit corrosion". Since Van Holstein had good experience with the Enviro-Shield kit, they also applied it to the stainless steel duct at Vector. And here also it proved to be the right solution. As can be seen on the recent image, the duct shines again and there are no signs of corrosion any more. Still the question remains why in this situation a good quality stainless steel started to "rust". The answer is quite simple, if you know what to look for. The street on which the Vector Building is situated crosses with a railway track just a few hundred yards away. Carbon steel particles coming from the tracks and the train wheels are transported by the wind and attach to the stainless steel duct. Once enough particles have attached themselves to the surface, even this stainless steel quality is not resistant any more and corrosion will occur.
