## Reducing time and costs cleaning Heat Recovery Steam Generators

Number: 2010/06

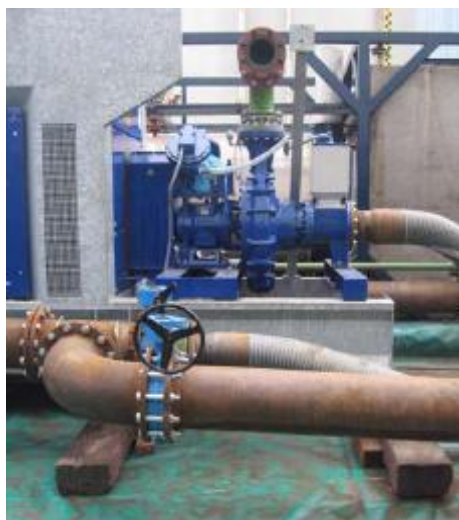
Photo 2: erection of the cleaning equipment (850 m<sup>3</sup>/h diesel driven pump)

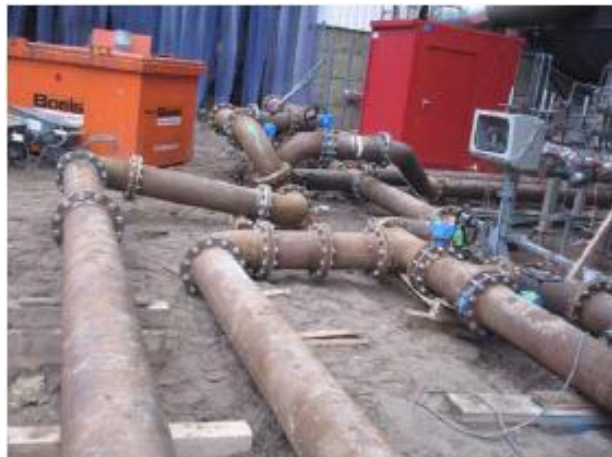
Photo 3: Temporary lines for chemical cleaning (DN250)

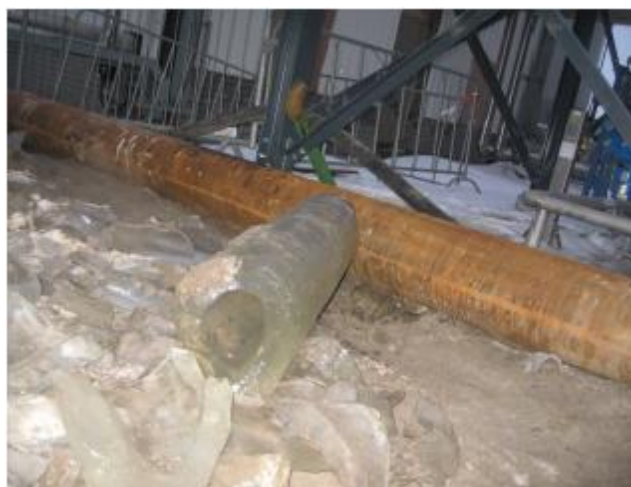
Photo 4: ice removed from demin-water line

As water starts to freeze, it expands. This can easily break steel pipes of any wall thickness. Preventing the lines and the boiler from freezing, the boiler and temporary lines were insulated. Heaters and hot air blowers were placed at all sides to keep the temperature of the system above zero. All these measures made it possible to successfully execute the cleaning process under extreme weather conditions.
