## Chemical cleaning of stainless steel coils of a feed heater

Number: 2011/01

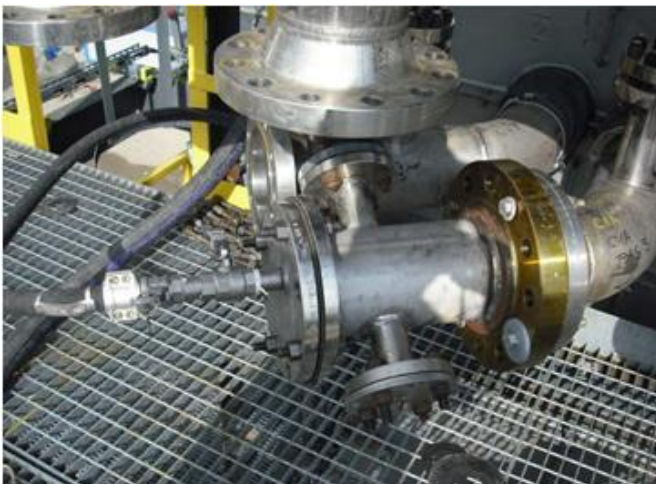
Receiver/launcher of the pigs

These pipes make a U-turn in which a drain is lacking. With the winter approaching and temperatures far below zero, remains of water in the lower part of the pipe system will freeze and cause severe damage. Because of the size of the system, the only effective way to remove all water is to dry it with pigs. To achieve that, large pigs were needed and especially, sufficient pressure in order to drive the pigs and the water left behind all the way down the system. Of course without losing pigs halfway.

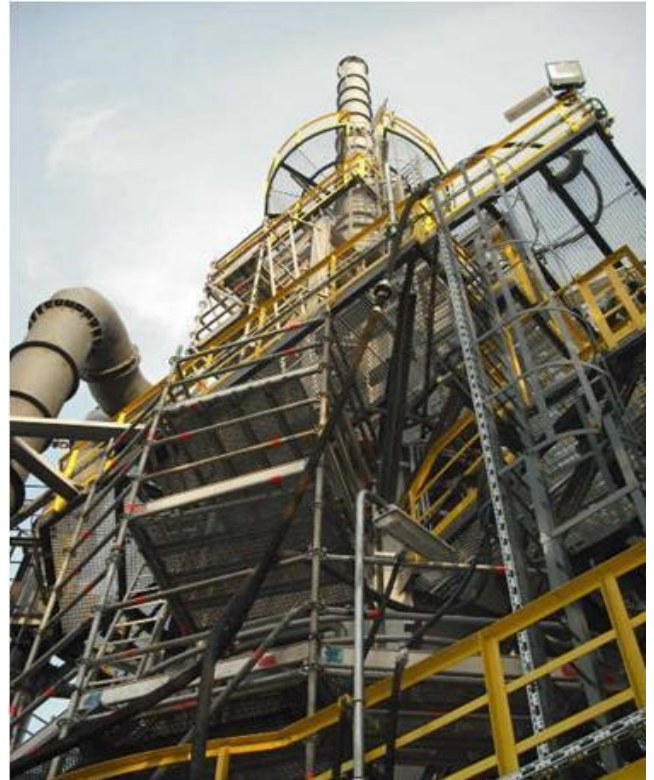
Feed heater

After pickling, the acid waste water is collected in collecting tanks and neutralized in situ to pH 7 with caustic soda. Thus meeting the standards of the waste water treatment system of the plant. The job is a quite standard procedure for Vecom, but there's one small problem. The heating coils are formed by four stainless steel pipes, discharging in two headers.

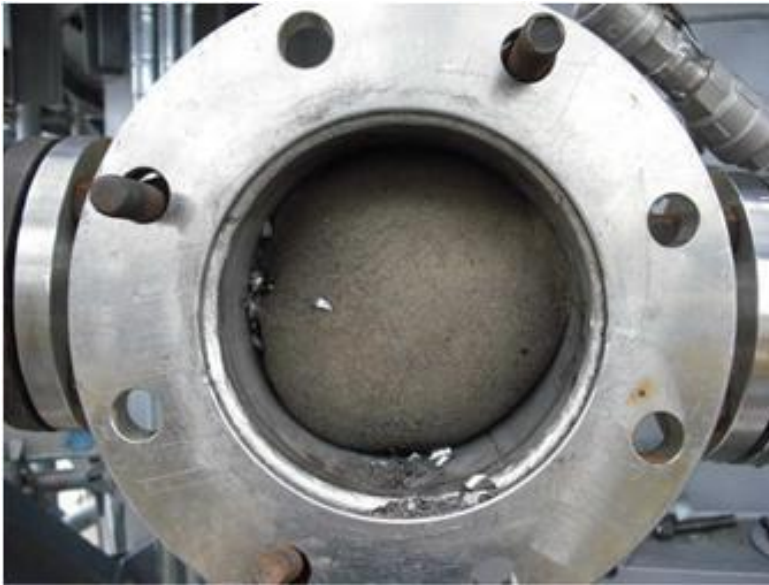
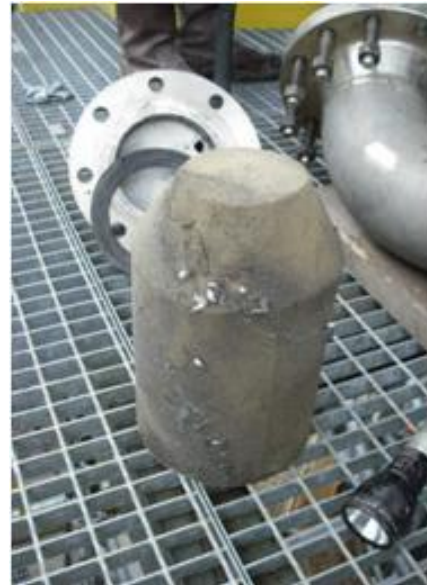
Return of the pig in the receiver

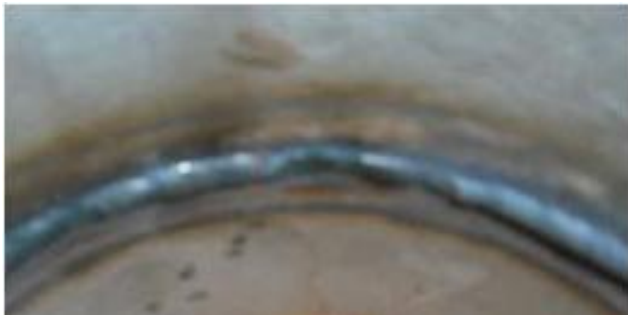
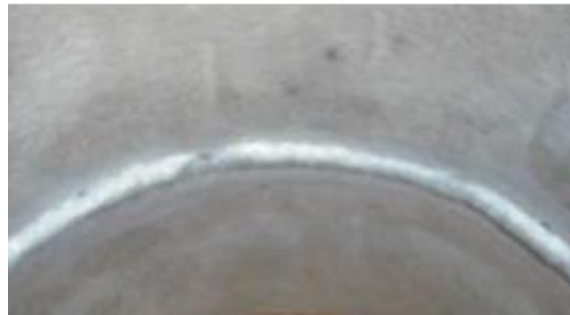
Discoloration before treatment and the result after pickling and passivating

To prevent corrosion, the stainless steel coils have been pickled and passivated with a mixture of hydrofluoric acid, nitric acid and a wetting agent. This treatment will remove the discoloration from welding and restore the corrosion resistance of the stainless steel surface by the formation of a passive chromium oxide film. Prior to this treatment, the system is degreased by circulating Vecom Multicleaner and completed by rinsing with demineralized water to neutral pH.

- Removal of blue heat tints from a test piece with a weld before and after pickling (see photo's next page).
- Amount of  $\mu\text{m}$  pickled from the stainless steel surface
