Technical Bulletin

Number: PRD 2004/01

Vecom helps to keep a shine on the stainless steel

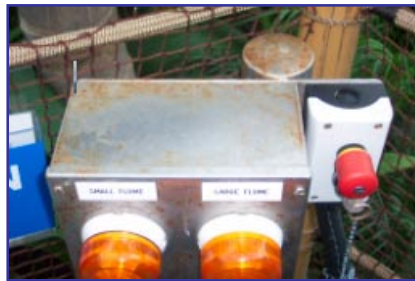
Before

The problem occurs when moist air, containing chlorine, condenses on the relatively cold stainless steel. The deposition on the surface causes corrosion. Initially the corrosion is not too serious, but brown staining appears rapidly which is a cause of concern. If the stainless steel is treated immediately, serious corrosion problems can easily be avoided.

The problem was solved by using Vecom Stainless Steel Cleaner to remove the brown staining, followed by Vecom Stainless Steel Polish to provide a bright shiny lustre.

Vecom recommends the use of 316 grade stainless steel or higher in this type of environment. The surface should be polished to achieve an Ra of 0.6 or less. The smoother the surface finish the more resistant it is to corrosion and staining. Pre polished sheet can be purchased before the equipment is fabricated but afterwards the welds should be pickled and all surfaces passivated to remove the workshop greases and iron contamination.
