CORROSION PROBLEM SOLVED BY "VECOSAN VLAKKENBEITS"

Deposit on stainless steel parts of car wash stations

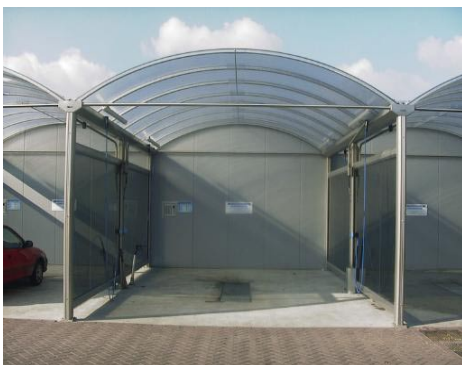
Within two weeks of installation, corrosion in the form of rust spots was detected.

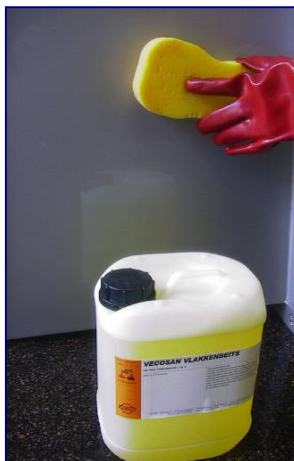
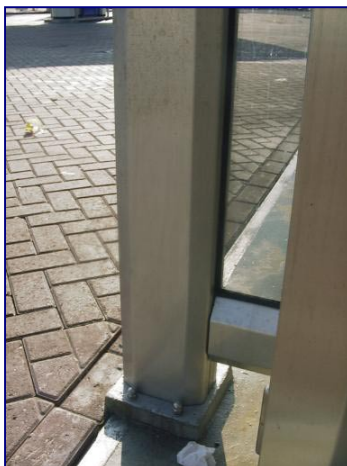
Deposit (upper surfaces) and after treatment with Stainless Steel Cleaner (lower surfaces)

The fact that the deposit could be removed with Stainless Steel Cleaner means that the corrosion was only slightly advanced.

Acting on our recommendation the manufacturer tried to remove the deposit with Vecosan Vlakkenbeits (Stainless Steel Cleaner), a post-treatment product for stainless steel and especially suitable for the removal of contamination after pickling has rendered the stainless steel passive. The result was positive.

Spray with concentrated Stainless Steel Cleaner. After allowing the agent to work in for about 20 minutes, rinse off thoroughly, preferably first with water under high pressure and then with low-chloride water (for example demineralized or (reversed) osmosis water). Corrosion may recur as a result of environmental factors (such as soap, chloride and lime) requiring this treatment to be repeated.
