Number: 2008/05

BOTTLE LANES IN BEER BREWERY FREE OF CORROSION AGAIN

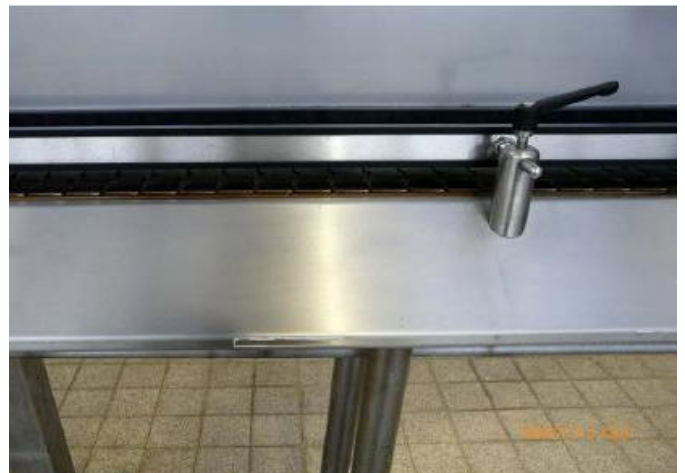
The bottle lanes of "line 8 and 16" were a particular cause for concern for the maintenance department. A treatment by the supplier of the bottle lanes appeared to be successful. However, the corrosion on the stainless steel returned again within several weeks. Inspectors from VECOM found the bottle lanes in a deplorable corrosive state. Measurements indicated that the fumes in the bottling plant were the main culprit. These fumes are released during addition of chemicals to the pasteuriser and the accompanying increased temperature. The chemical additives used in the lubrication of the lanes add to the problem. If the oxide skin has not been treated optimally, stainless steel AISI 304 will show signs of corrosion under such conditions. If maintenance is then performed near the plating, any remaining iron particles will leave visible traces of corrosion.

The heavily corroded stainless steel bottle lanes of lines 8 and 16 are pickled first and then treated with two types of protective sprays. After this treatment, a second pickling treatment is performed with the new product VECINOX. This makes the oxide skin of the stainless steel become passive more quickly and strongly reduces the chances of staining.

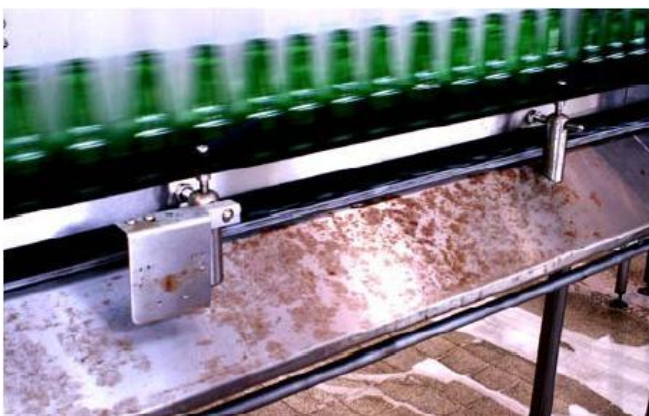
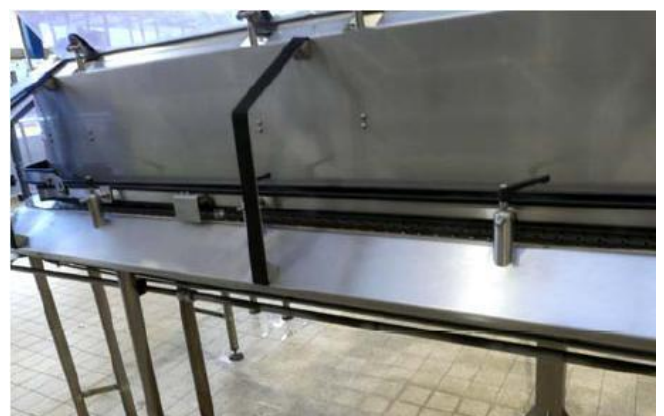
Before and after treatment

The approach by VECOM appears to be successful. No further corrosion was observed since the pickling treatment was performed. Not even on the plates that were merely pickled. However, for added certainty about stainless steel AISI 304 in this aggressive environment, it is recommended that the stainless steel plating and parts be waxed after pickling. We also advise this method for stainless steel objects in other corrosive environments such as indoor swimming pools: railings, gates, foundations of diving boards, door hinges, advertising signs, etc. This also applies to works of art and stainless steel constructions in the offshore industry. In a maritime climate even the stainless steel type AISI 316 is not recommended and we recommend the stainless steel type Duplex.
